Parts Required: Cylinder
 Actuator
 Lever (locking) or Ball Barring (non-locking)
 Cable Clip

Tools Used: 17mm or 11/16" Wrench
 Pliers or Vice Grips

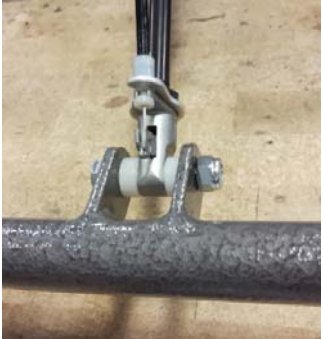
Step	Execution	Figures
1	<p>Note: Cylinder does not need to be removed from the chair to make this adjustment.</p> <p>**Chairs and cylinders assembled after October. 4th, 2016 do not require an adjustment. New design of cable clip includes a washer that allows the cable clip to rotate freely, which allows manufacturing to pre-set the actuator to a correct depth (no over or under tightening), preventing cylinder malfunctions. If troubleshooting issues arise, please contact Broda Customer Service.</p>

2	<p>Loosen the lock nut located on the stem of the gas cylinder next to the actuator. You will need to wind the stem further into the actuator if the chair is not tilting or reclining, (wind it clockwise) and wind it further out of the actuator if the chair is slowly sliding out of position. (wind it counter-clockwise)</p>

3	<p>Wind the stem in the correct direction one half turn. When viewing the cylinder with stem pointing towards you turn the stem clockwise to wind the stem out of the actuator and counter-clockwise to wind the stem into the actuator. A cloth, piece of vinyl strap, or some other protective material must be used to protect the sliding surface of the rod.</p>

4	<p>Check the function of the cylinder by tilting or reclining the chair and repeat previous steps until the cylinder functions properly.</p>	
5	<p>Tighten the lock nut loosened in step 2</p>
